INSPECTION REPORT

For the Property at:
123 ANY ST
MY TOWN, ON

Prepared for: COSTUMER
Inspection Date: Saturday, October 22, 2022
Prepared by: Gus Asikelis

RE: Report No. 1005, v.3
123 any st
My Town, ON

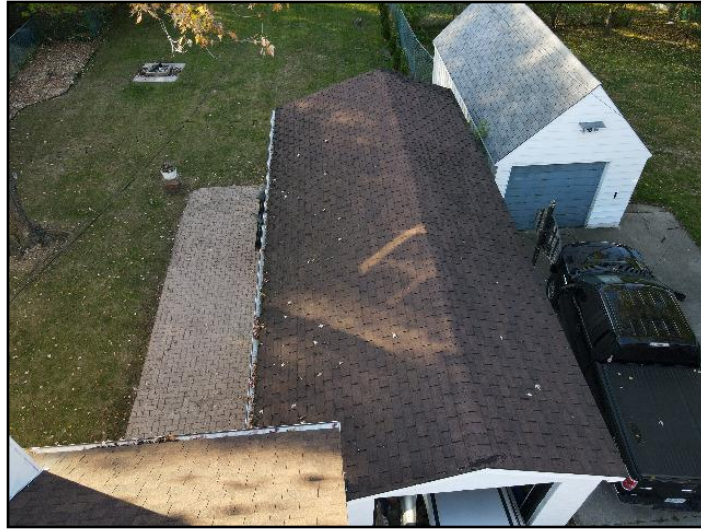
1. **Condition:** • [Near end of life expectancy](#)

Implication(s): Chance of water damage to structure, finishes and contents

2. *Old, worn out*

Task: Replace

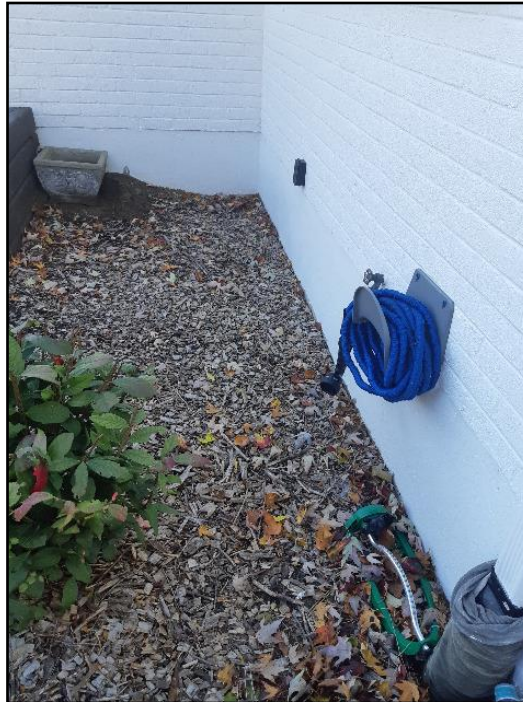
- [Towards building](#)
recommend to add dirt and change the slope away from the building

13. Towards building

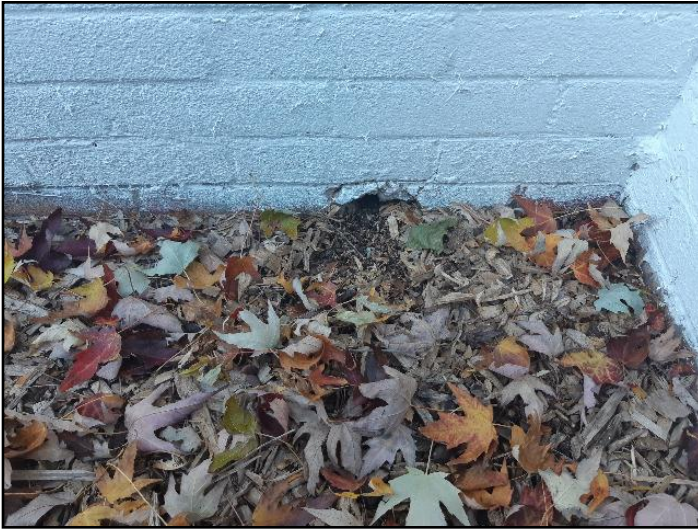
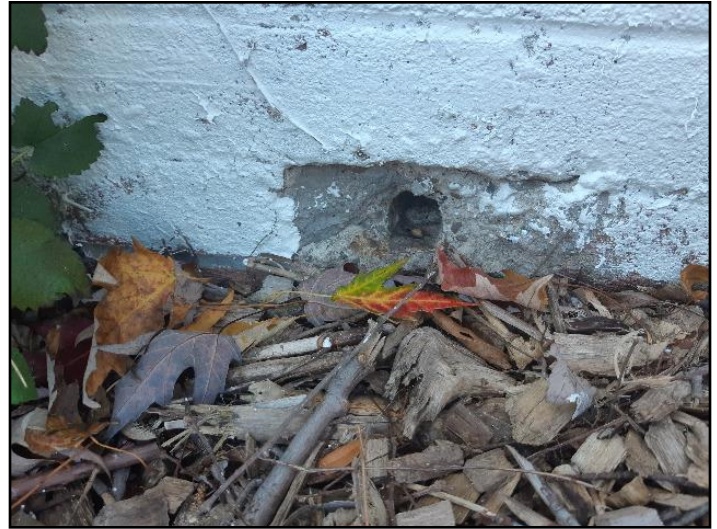
3. Condition: • Recommend any holes around the house to be plugged in to prevent pest activity enter the house and prevent draft air to enter as well.

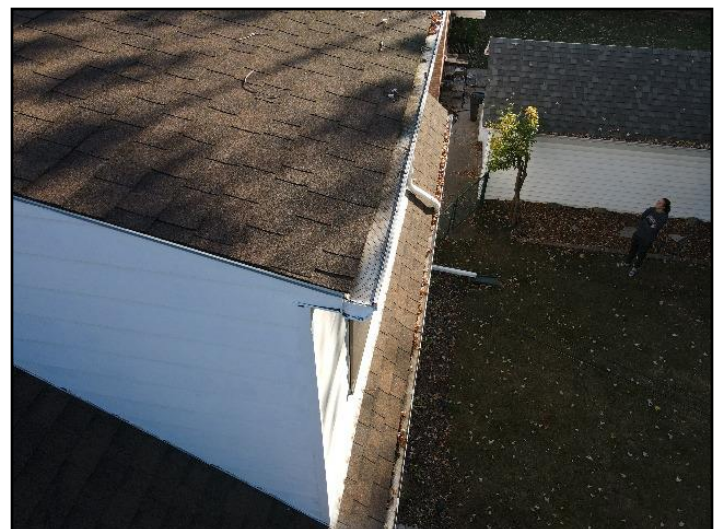
5. Condition: • Dirty/debris

31. Dirty/debris

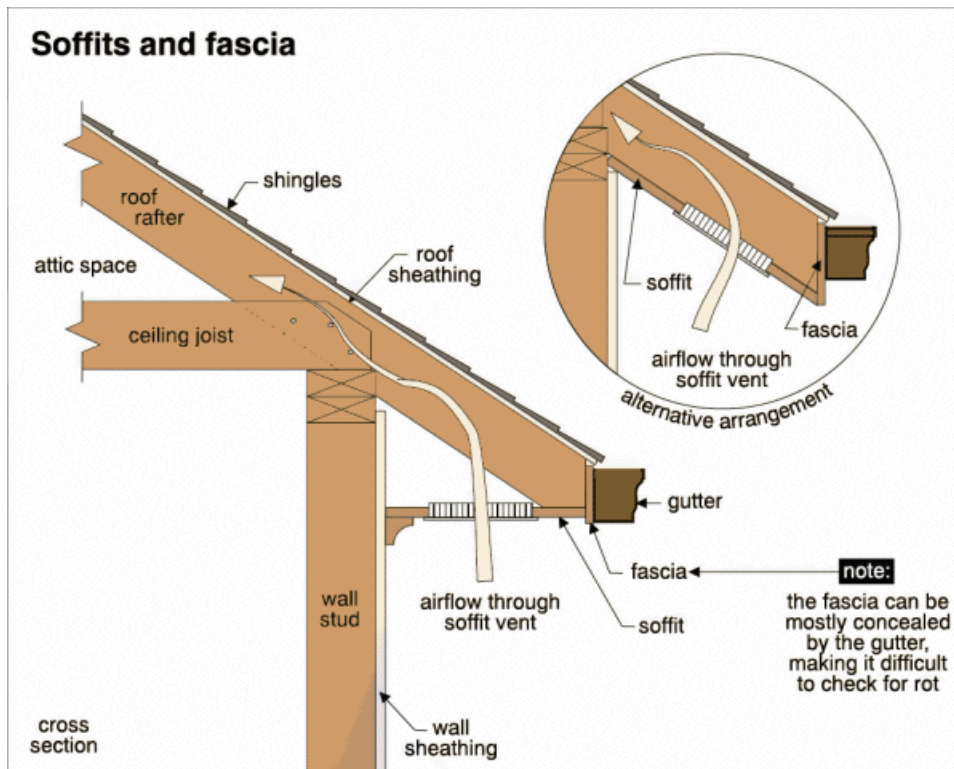
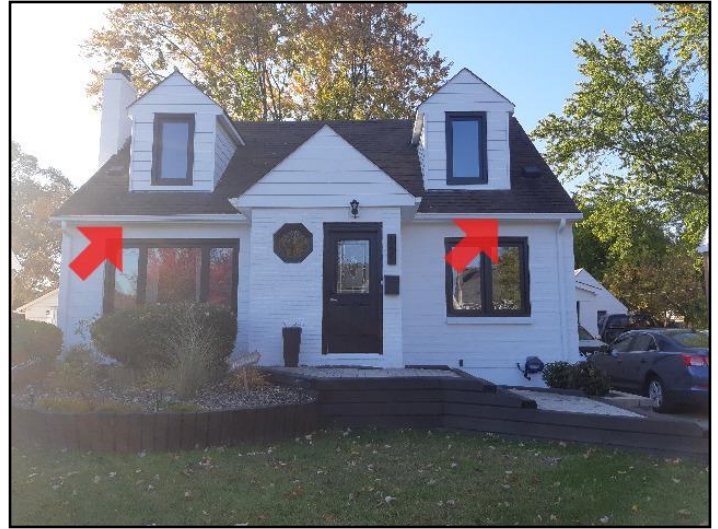
6. Condition: • [Vents - ineffective / missing](#)

solid soffits around the house, lack of ventilation at the corners. The garage has vinyl soffits proper ventilation was found on the day of the inspection

Implication(s): Chance of condensation damage to finishes and/or structure | Material deterioration

34. solid soffits lack of venting

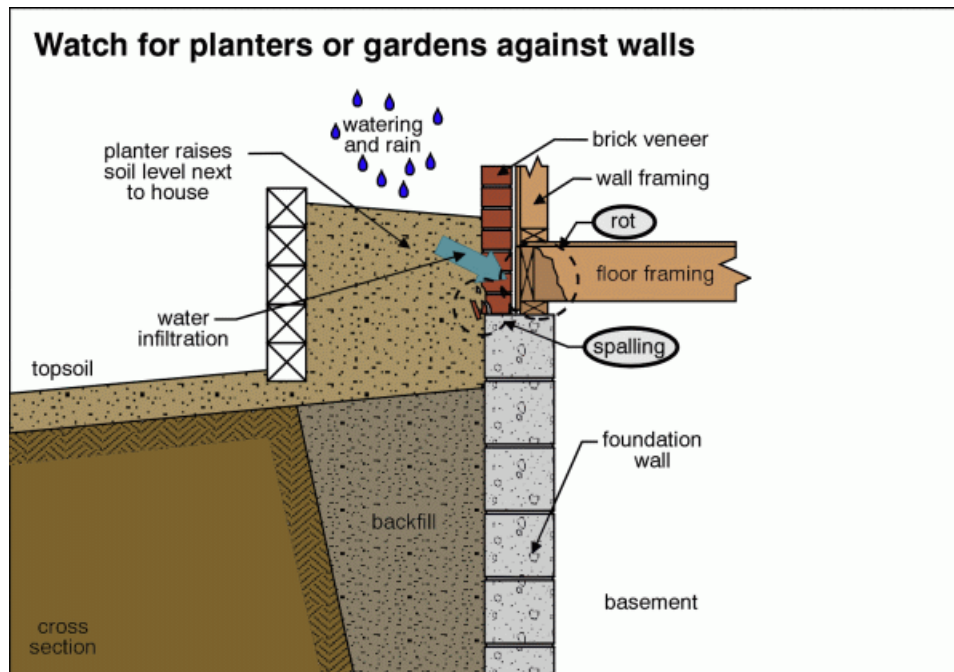
10. Condition: • [Planters and gardens against walls](#)

Implication(s): Chance of water entering building | Chance of damage to structure | Chance of structural movement

remove any vegetation like tree roots that are attached or less than 3 feet to the foundation around the house to prevent moisture enter the building.

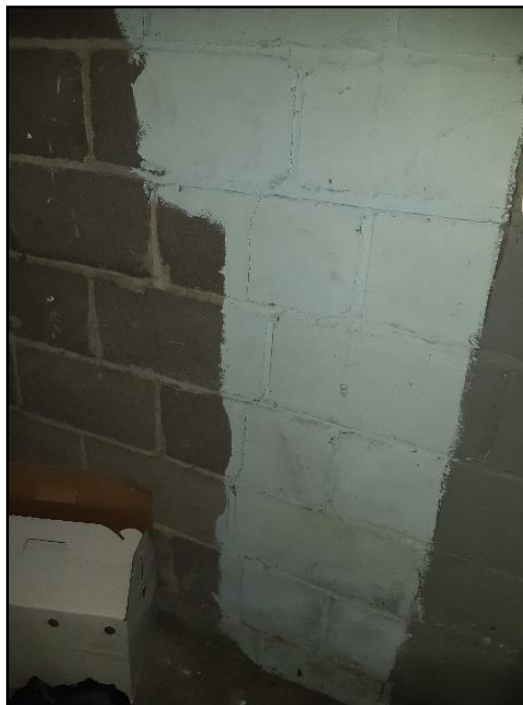
12. Condition: • Typical minor cracks

minor crack was present on the day of the inspection. apply a sealant to prevent water leaks and monitor annually, if the crack deteriorates recommended to get a further evaluation from a structural engineer

47. Typical minor cracks

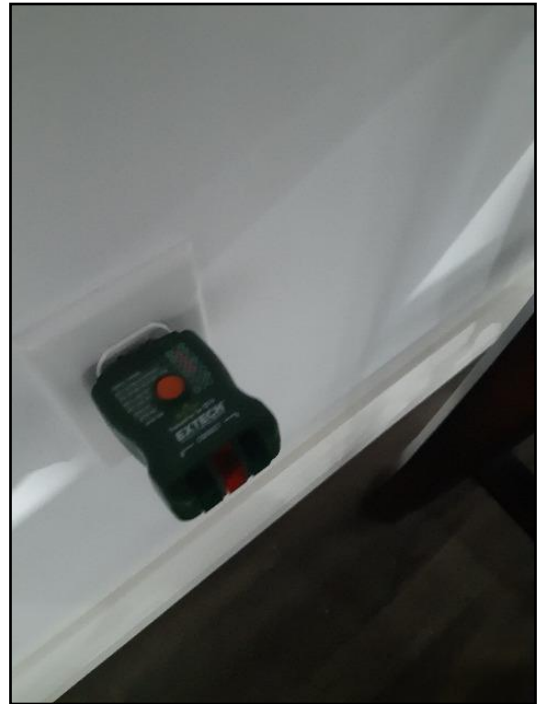
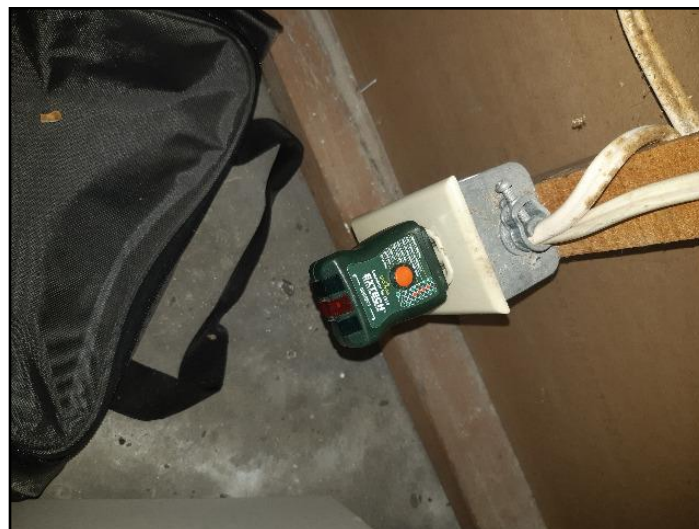
14. Condition: • [Inoperative](#)

54. Inoperative

55. Inoperative

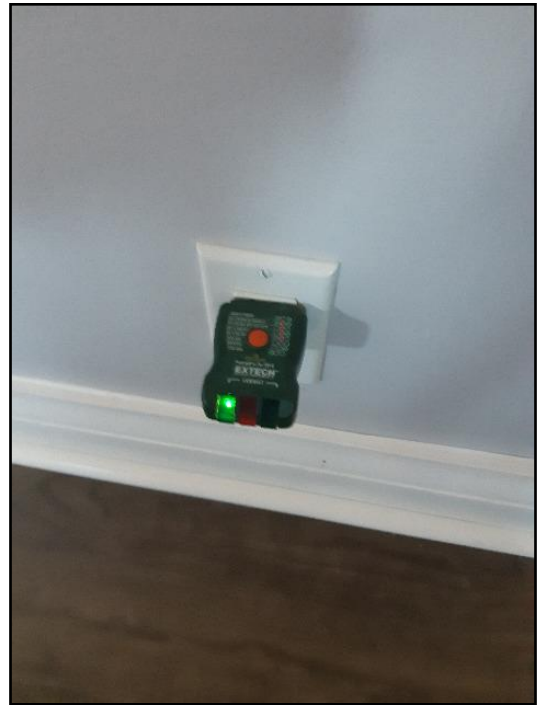
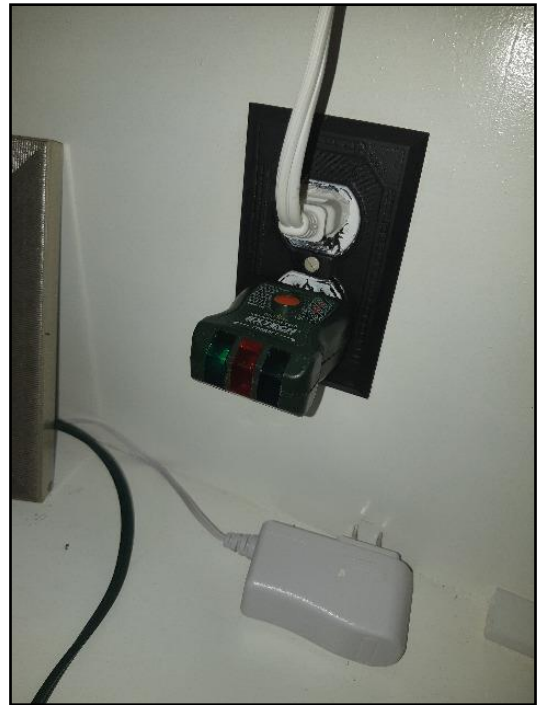
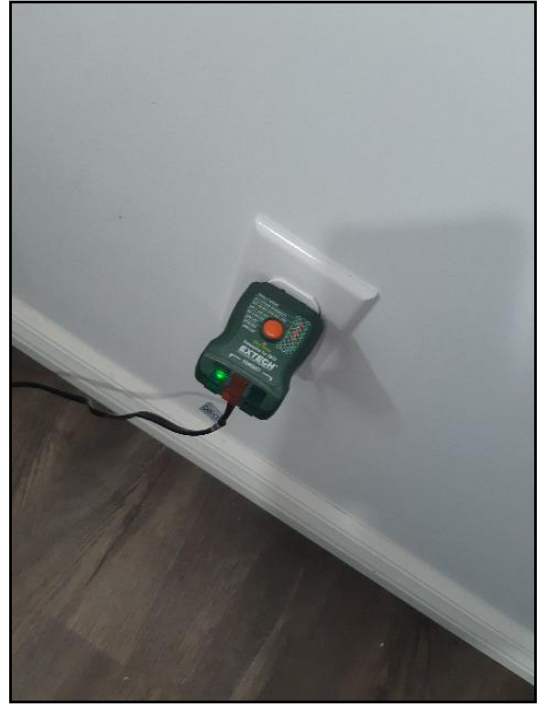
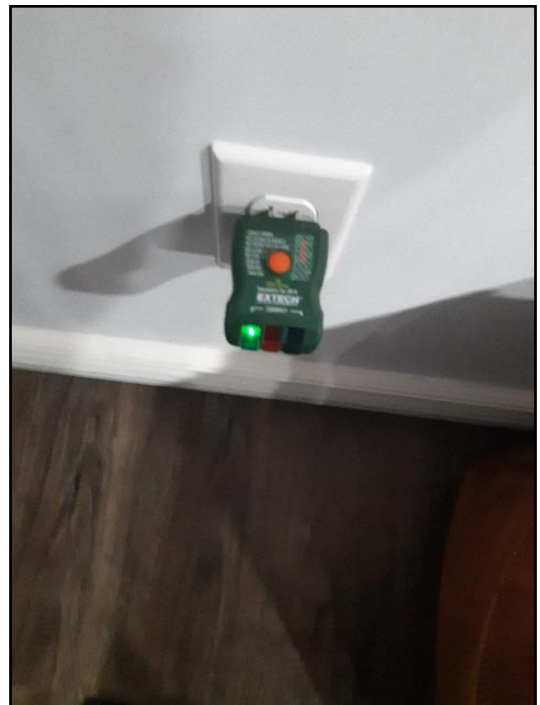
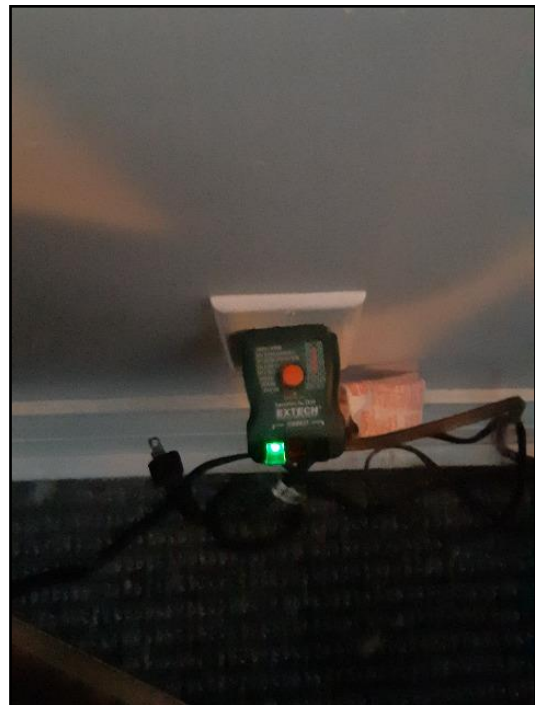
15. Condition: • [Ungrounded](#)

recommend all outlets be inspected and corrected accordingly by a licenced electrician. On the day of the inspection found most of the outlets were ungrounded.

57. Ungrounded

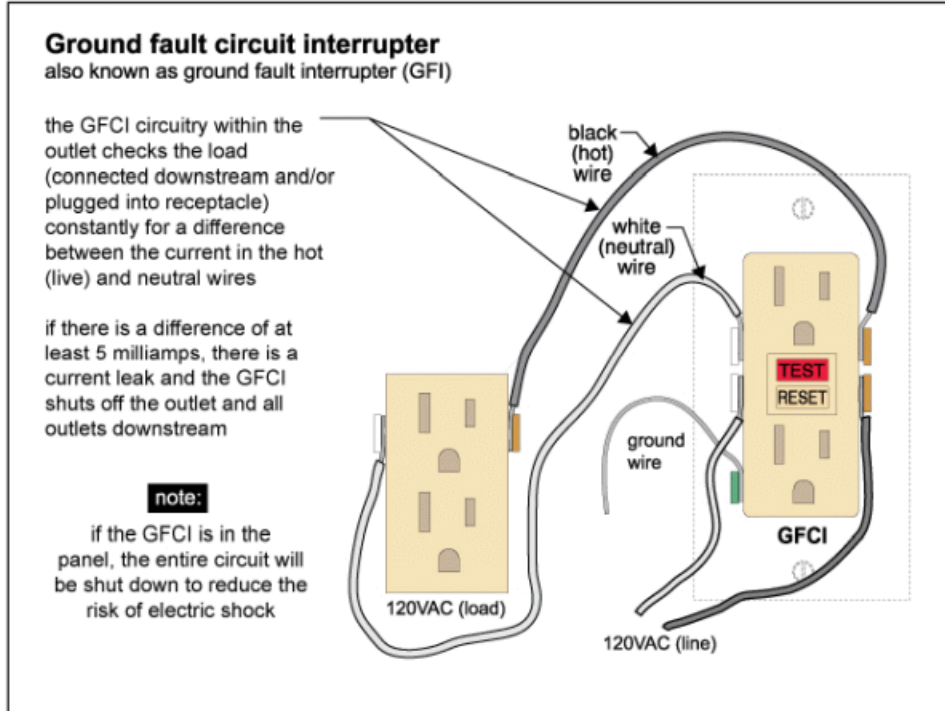
16. Condition: • [No GFCI/GFI \(Ground Fault Circuit Interrupter\)](#)

68. No GFCI/GFI (Ground Fault Circuit...

recommend GFCI outlets be installed on the ground floor bathroom, laundry room and in the kitchen by a licensed electrician.

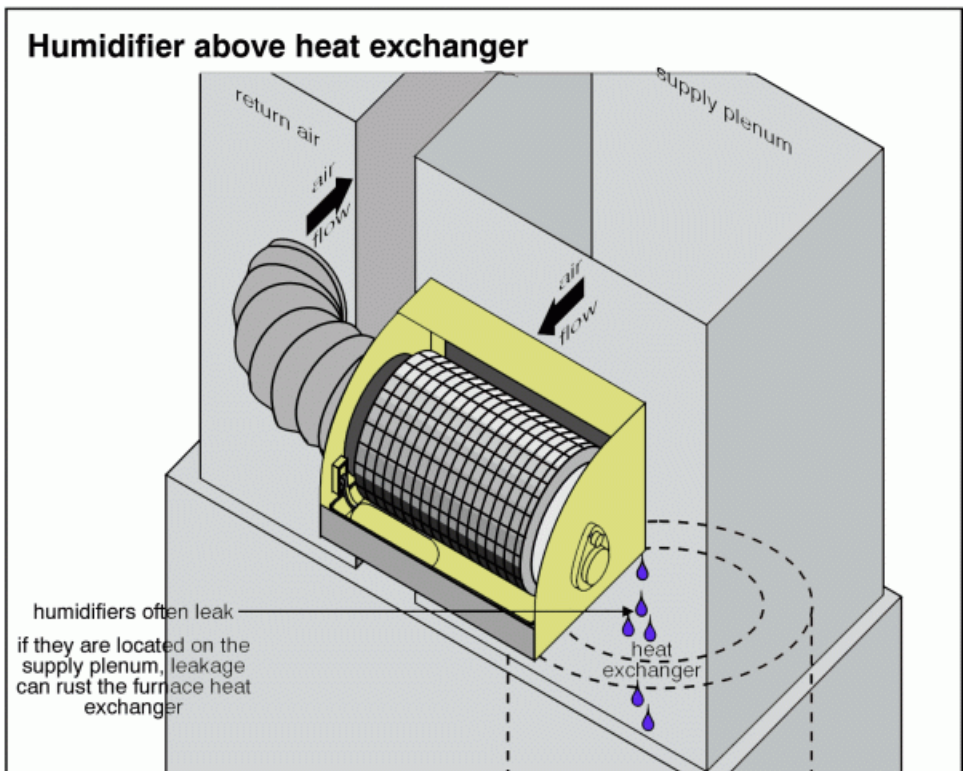
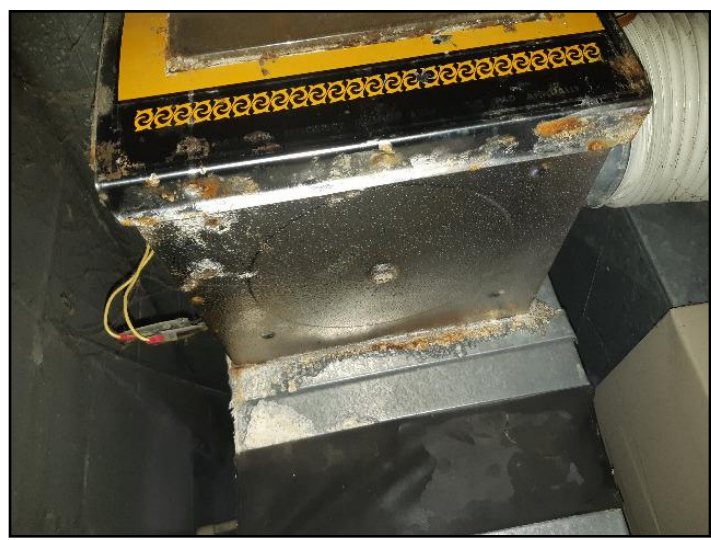
20. **Condition:** • [Leak](#)

Implication(s): Chance of water damage to structure, finishes and contents | Damage to equipment

74. Leak

Task: Repair or replace

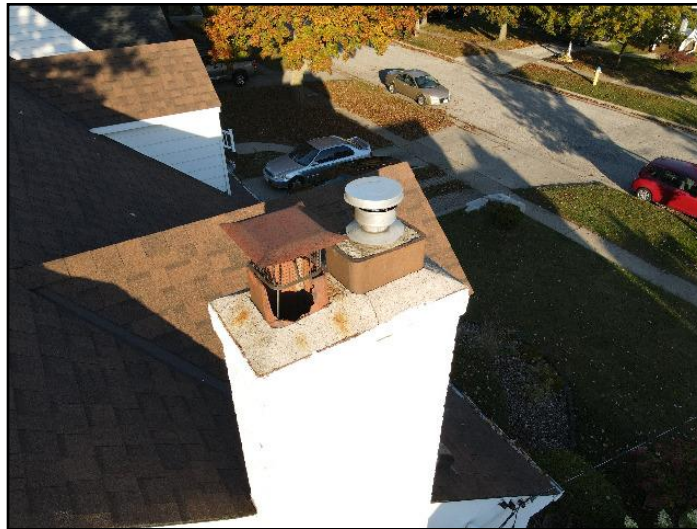
21. Condition: • [Cracked](#)

Chimney's clay liner was found broken on top on the day of inspection. Further evaluation is recommended by a chimney specialist to evaluate the integrity of the whole flue liner and repair it accordingly.

Implication(s): Chance of water damage to structure, finishes and contents | Shortened life expectancy of material

75. Cracked

Task: Repair, further evaluation

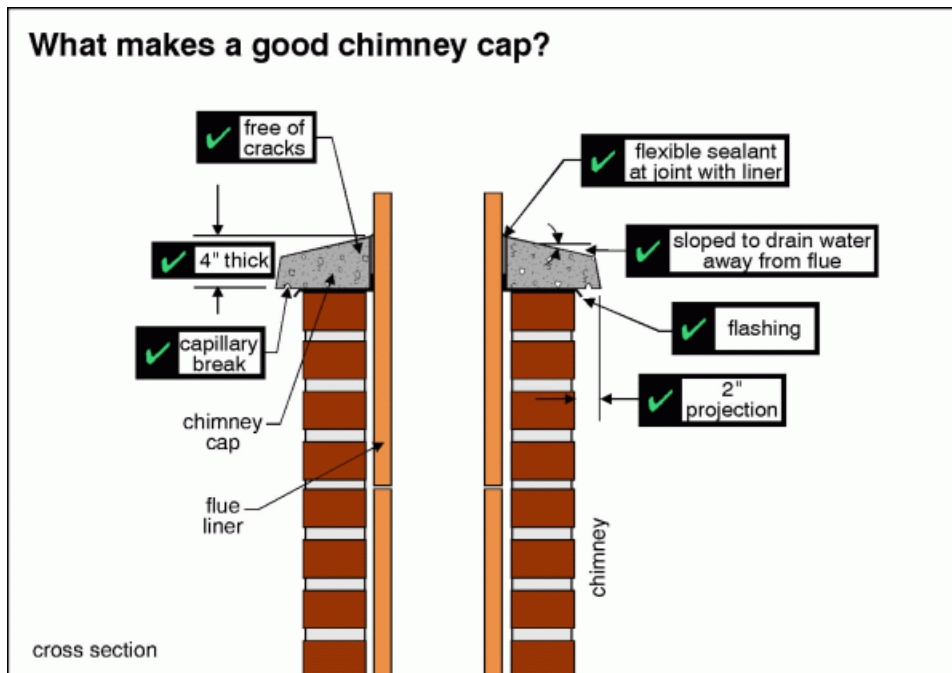
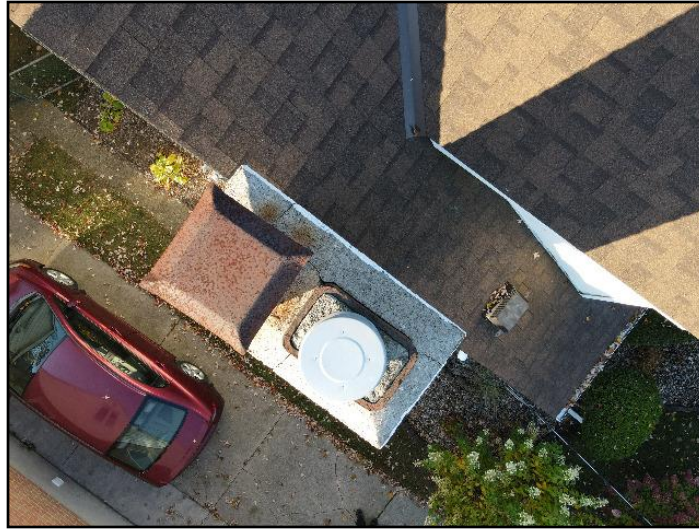
22. Condition: • [Cracked](#)

3 minor cracks are present, recommend being sealed to reduce further deterioration

Implication(s): Chance of water damage to structure, finishes and contents | Shortened life expectancy of material

76. Cracked

Task: Repair

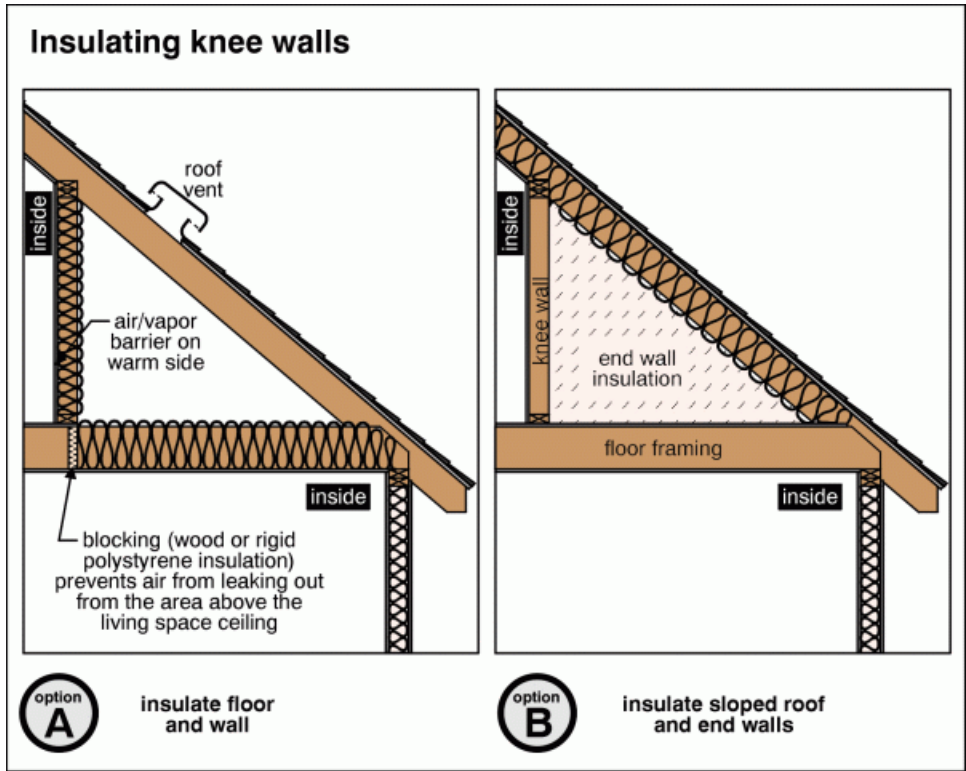
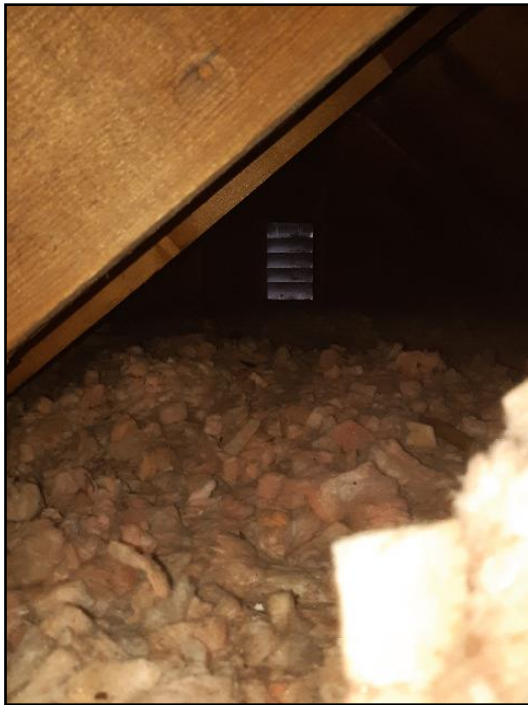
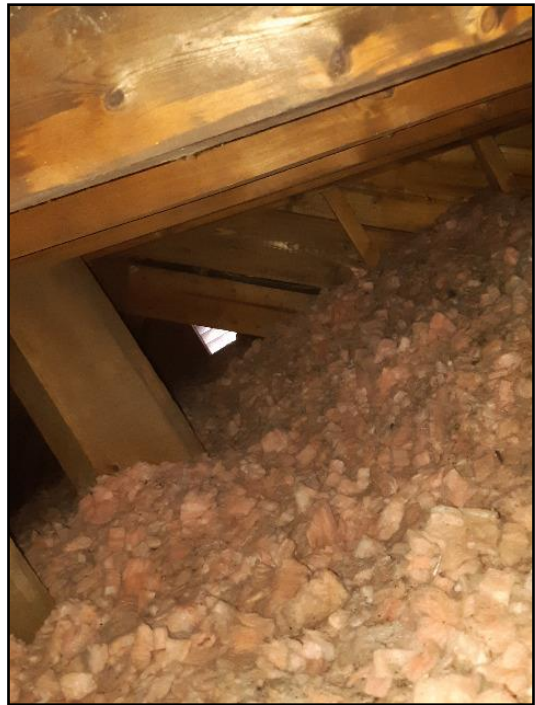
24. Condition: • [Inadequate in knee wall areas](#)

85. Inadequate in knee wall areas

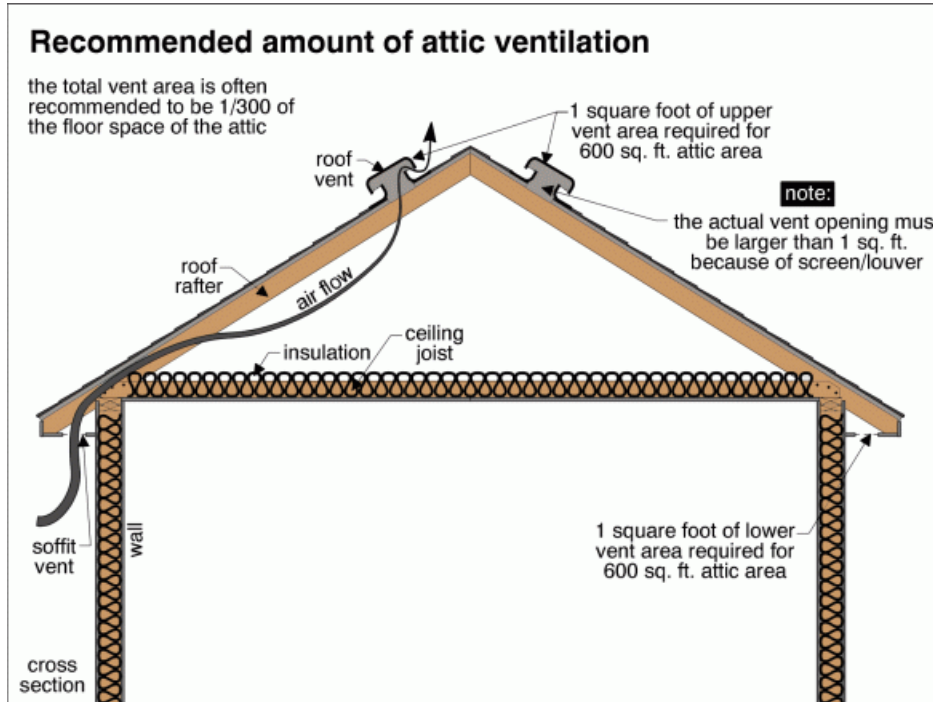
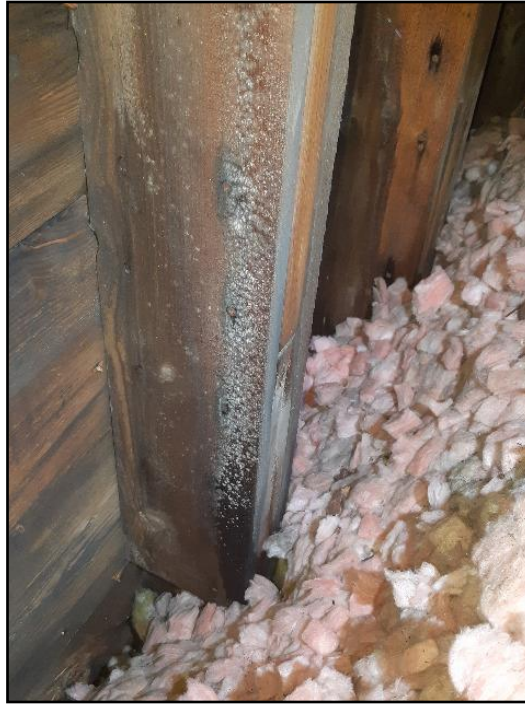
25. Condition: • [Inadequate](#)

Due to solid soffits, recommend being installed one power vent on one of the gable vents to prevent any condensation. Visible mildew is present on one rafter in the attic. Recommend to be cleaned with bleach and monitor the roof seasonally. No leaks were present on the day of inspection.

Implication(s): Chance of condensation damage to finishes and/or structure

87. *Inadequate*

Task: Improve

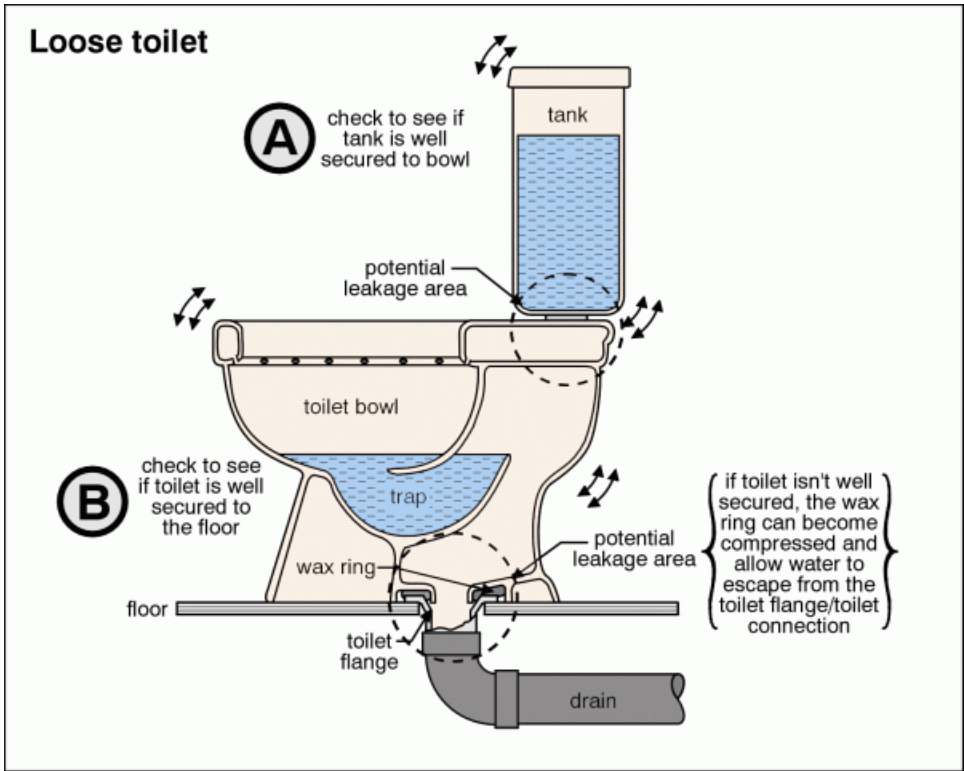
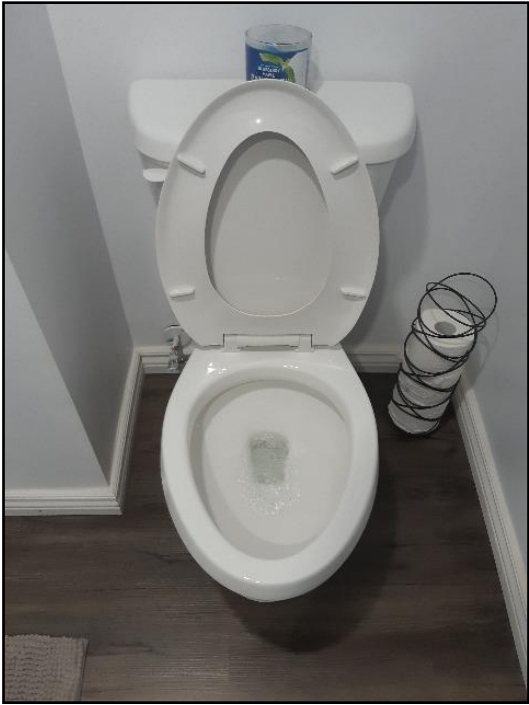
30. Condition: • [Loose](#)

Recommend to be properly mounded on the floor. Found loose the day of inspection

Implication(s): Chance of water damage to structure, finishes and contents | Sewage entering the building | Possible hidden damage

104. Loose

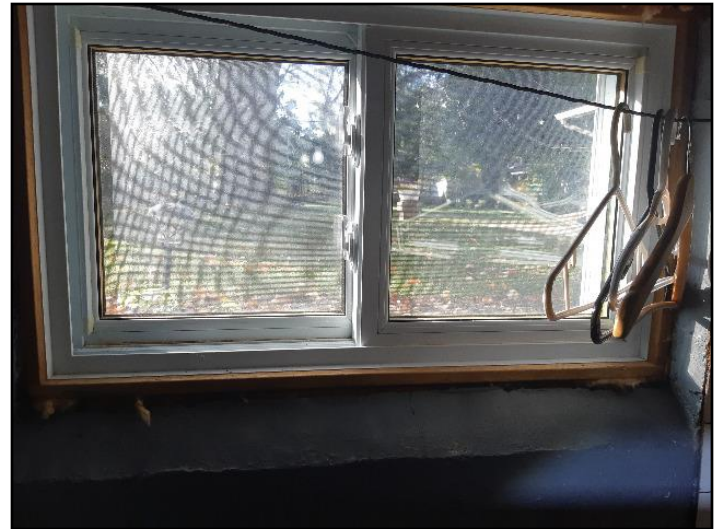
32. Condition: • [Poor fit](#)

recommend filling cracks around the laundry area windows in the basement with foam to prevent draft air enter the building

Implication(s): Material deterioration

127. Poor fit

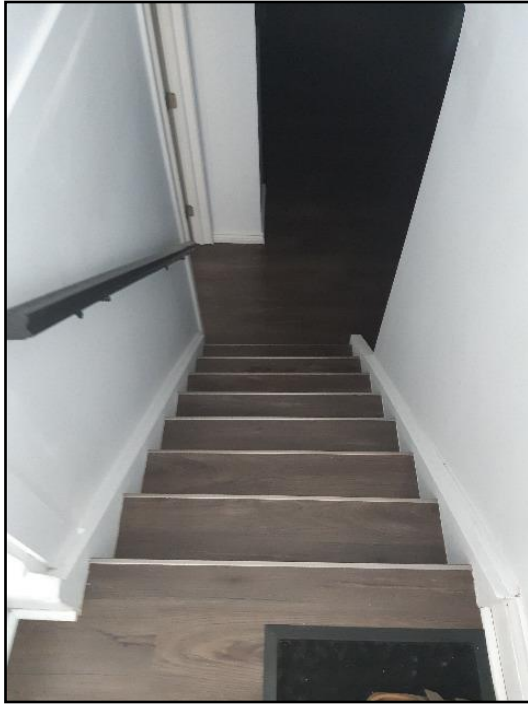
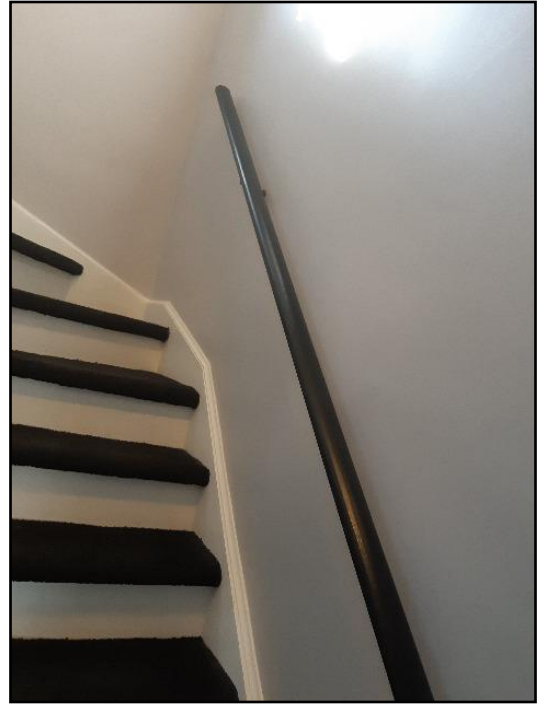
33. Condition: • [Loose](#)

Implication(s): Fall hazard

128. Loose

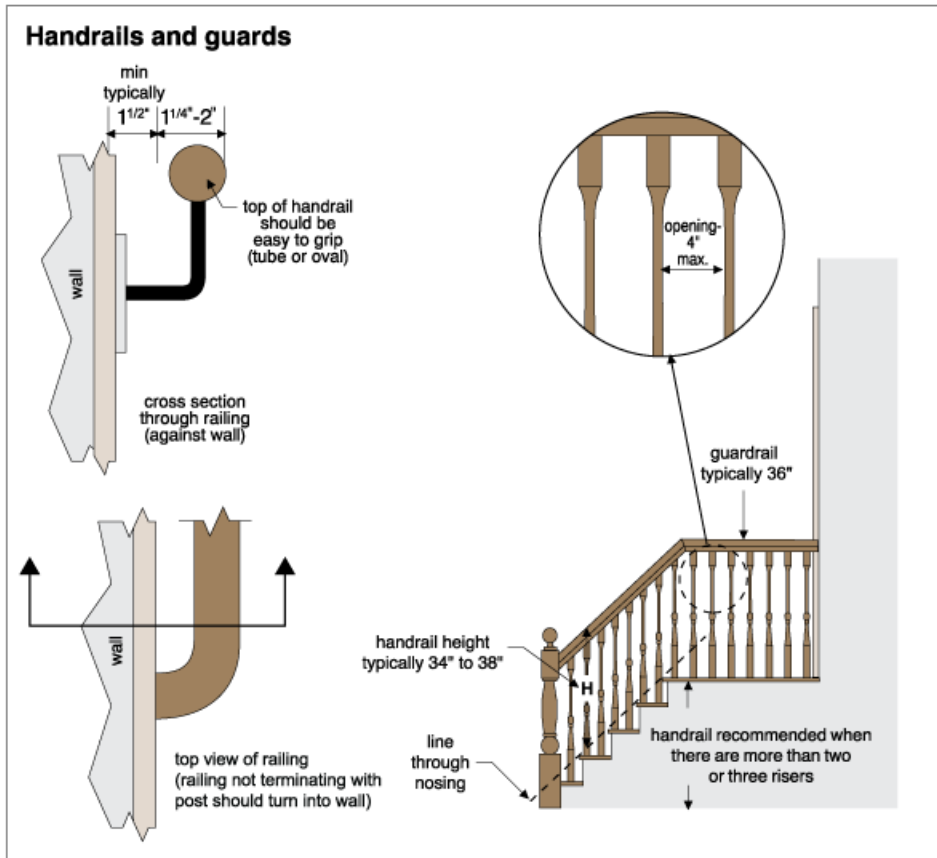
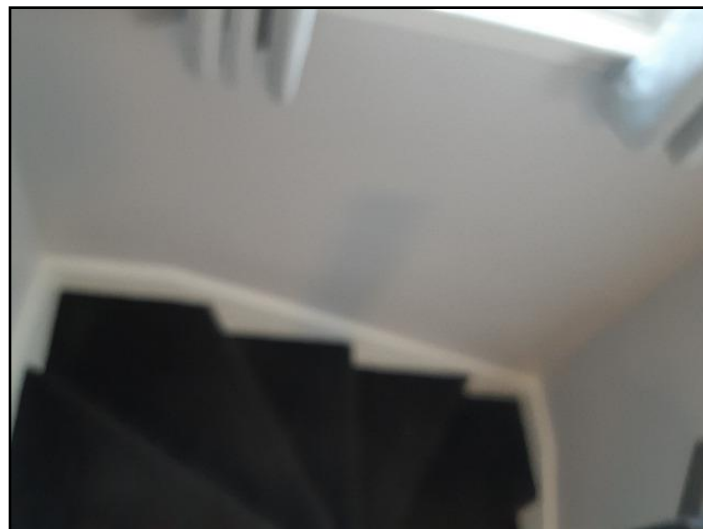
34. Condition: • [Missing](#)

Implication(s): Fall hazard

130. Missing

recommend a handrail to be installed
