INSPECTION REPORT

For the Property at:
123 ANY ST
MY TOWN, ON

Prepared for: COSTUMER
Inspection Date: Saturday, October 22, 2022
Prepared by: Gus Asikelis

RE: Report No. 1005, v.3
123 any st
My Town, ON

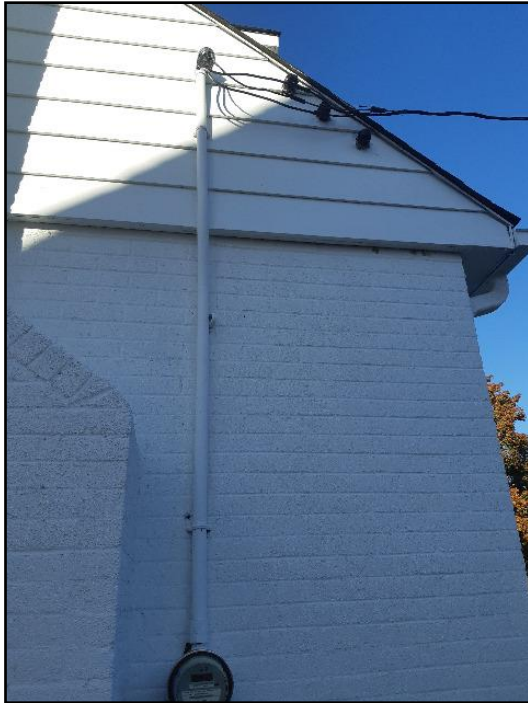
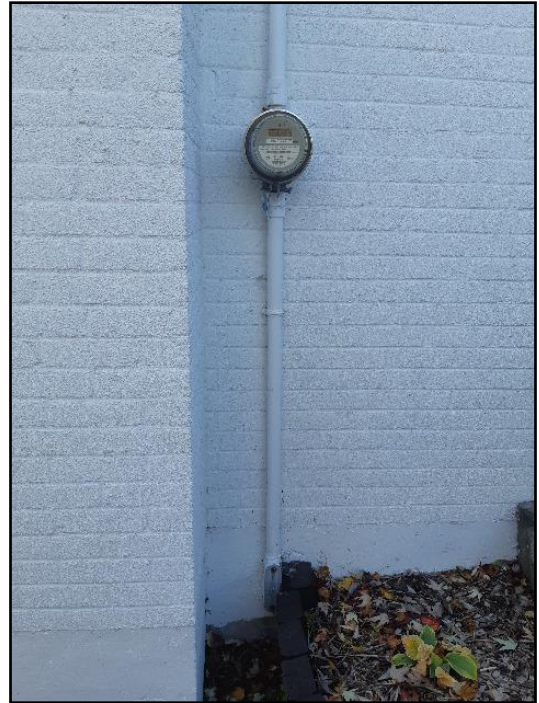
- [Overhead - cable type not determined](#)
fair condition on the day of inspection

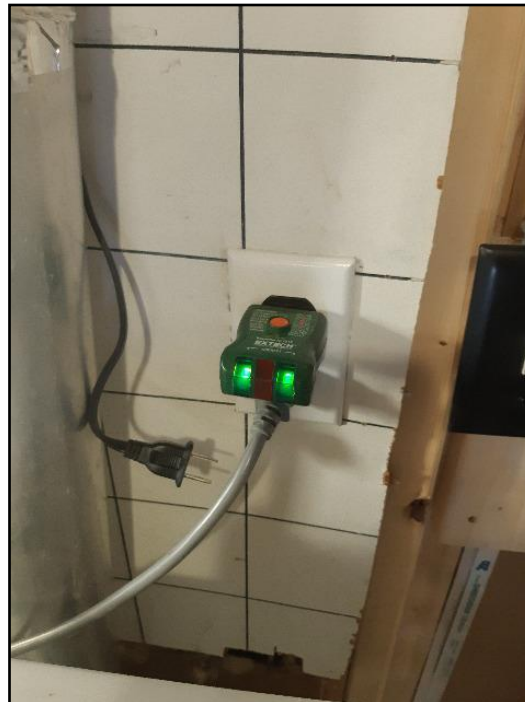
68. No GFCI/GFI (Ground Fault Circuit...

16. Condition: • [No GFCI/GFI \(Ground Fault Circuit Interrupter\)](#)

recommend GFCI outlets be installed on the ground floor bathroom, laundry room and in the kitchen by a licensed electrician.

Task: Correct
