INSPECTION REPORT

For the Property at:
123 ANY ST
MY TOWN, ON

Prepared for: COSTUMER
Inspection Date: Saturday, October 22, 2022
Prepared by: Gus Asikelis

RE: Report No. 1005, v.3
123 any st
My Town, ON

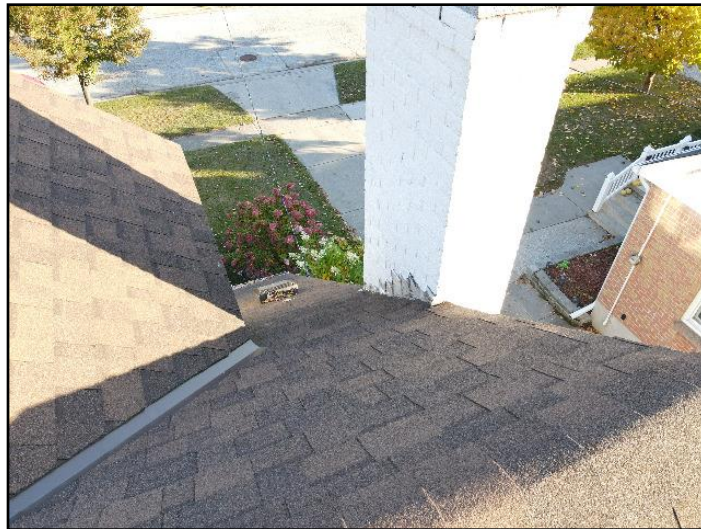
3.

2. **Condition:** • re-caulking flashing area every 2-4 years to prevent moisture enter the roof

Task: Monitor

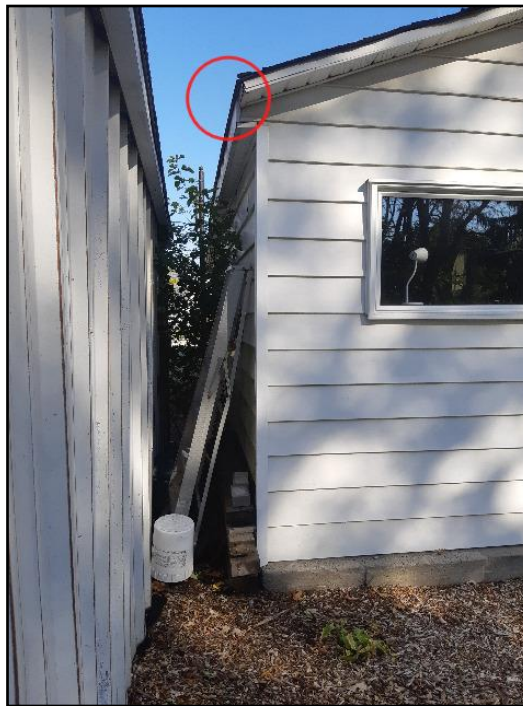
29.

4. Condition: • Missing

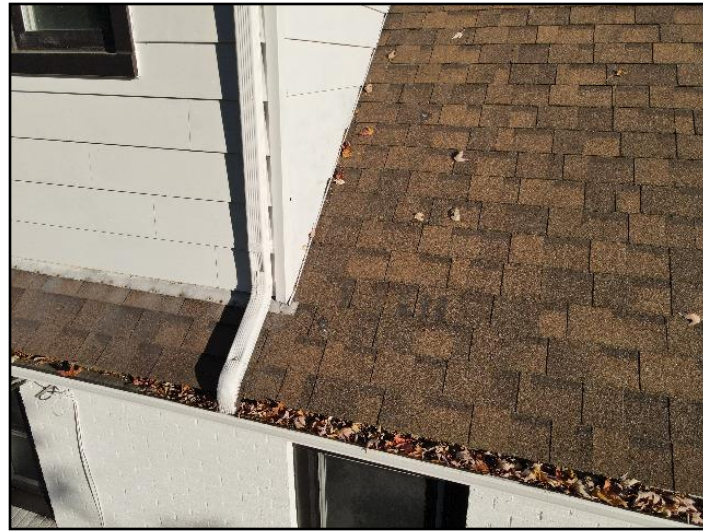
5. Condition: • Dirty/debris

32. Dirty/debris

Task: Clean, Seasonal

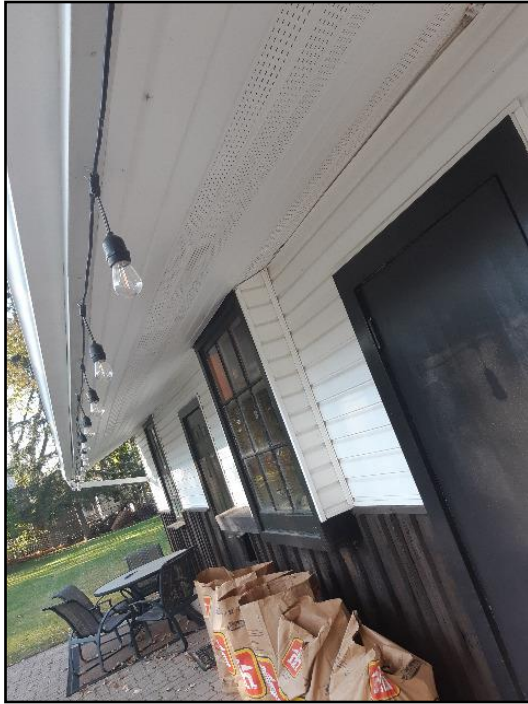
6. Condition: • [Vents - ineffective / missing](#)

solid soffits around the house, lack of ventilation at the corners. The garage has vinyl soffits proper ventilation was found on the day of the inspection

Implication(s): Chance of condensation damage to finishes and/or structure | Material deterioration

33. soffits garage

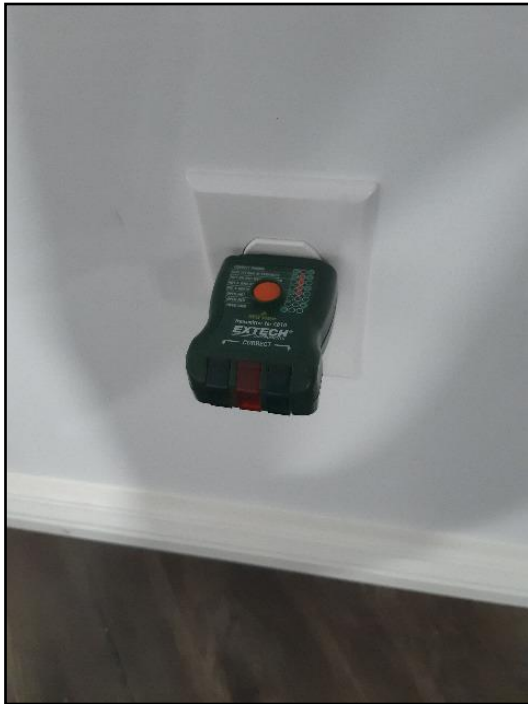
53. Inoperative

14. Condition: • [Inoperative](#)

Time: As soon as possible

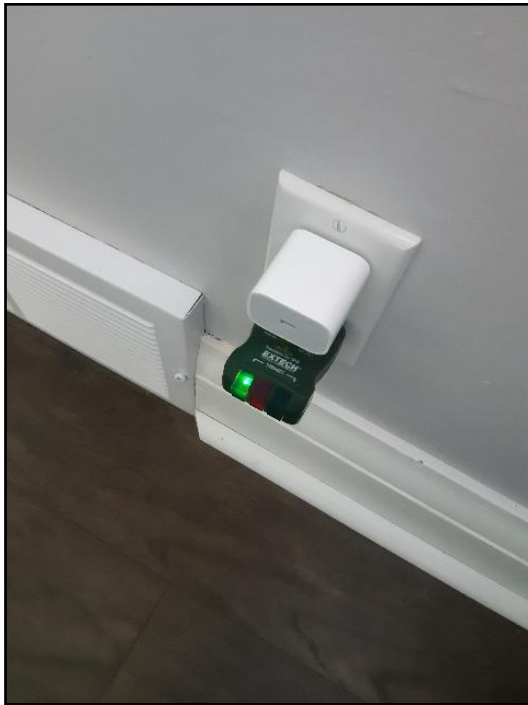
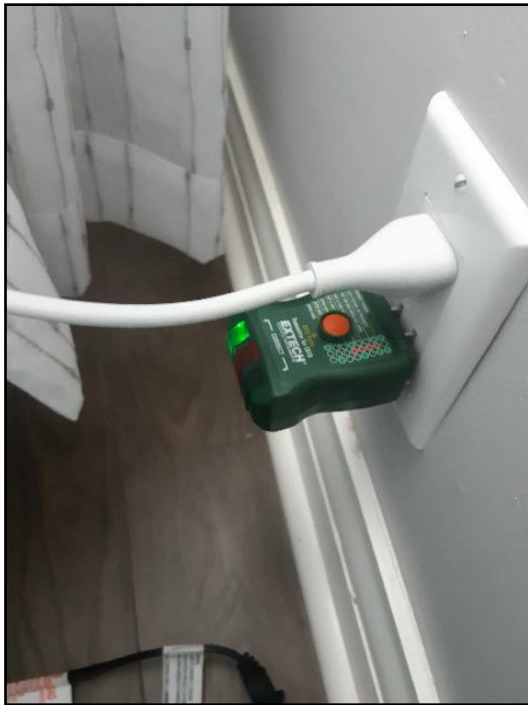
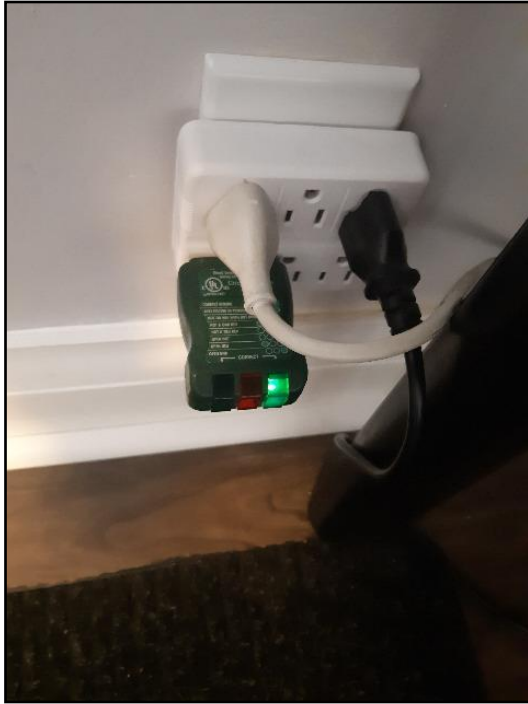
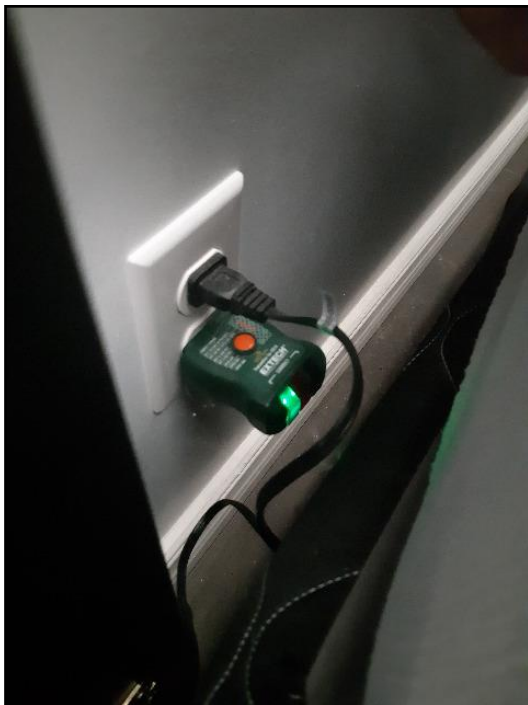
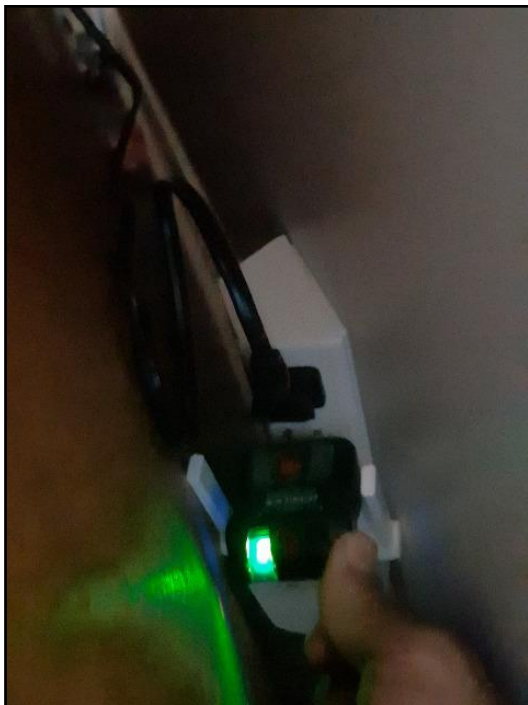
15. Condition: • [Ungrounded](#)

recommend all outlets be inspected and corrected accordingly by a licenced electrician. On the day of the inspection found most of the outlets were ungrounded.

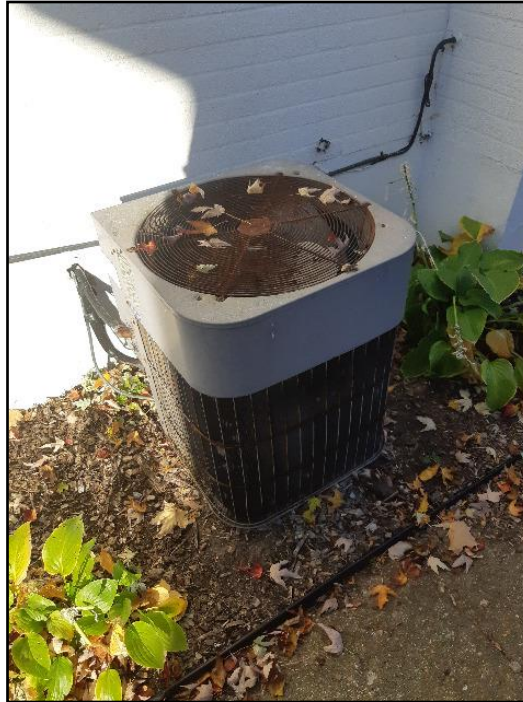
78. Past life expectancy

23. Condition: • Past life expectancy

Implication(s): Equipment failure | Reduced comfort

recommend upgrading the A/c unit to high efficiency. Keep the unit clean of debris and service it seasonal. Recommend to be covered at the winter time.

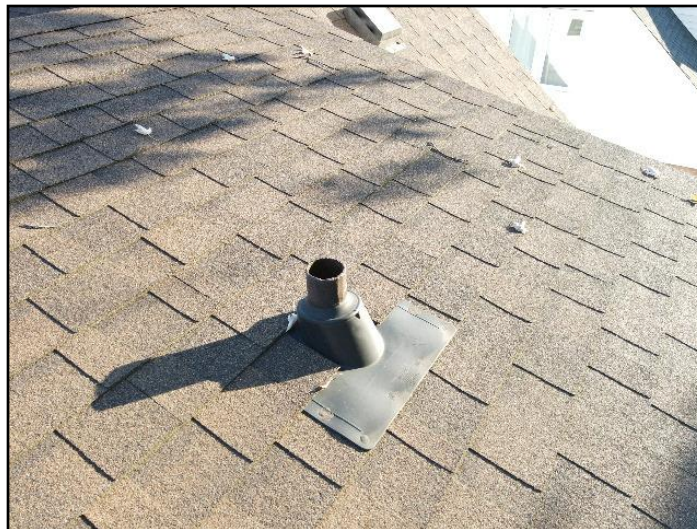
103.

28. Condition: • Fair condition on the day of inspection, no correction needed.

Location: South Roof

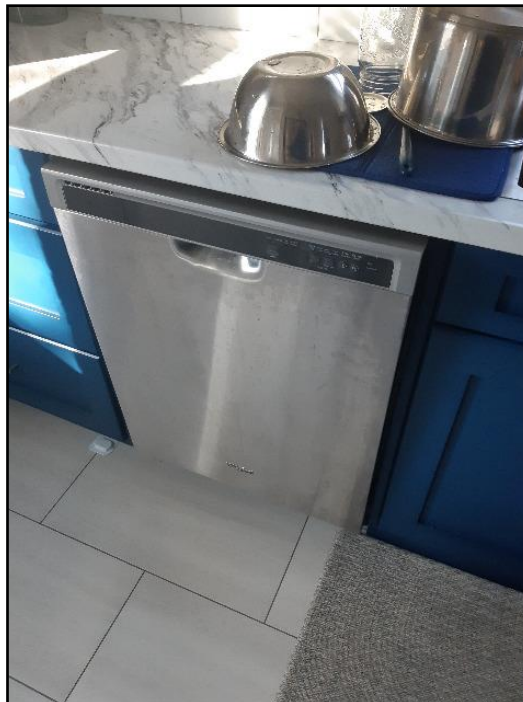
105. *Dishwasher*

• Dishwasher

normal operative on the day of inspection

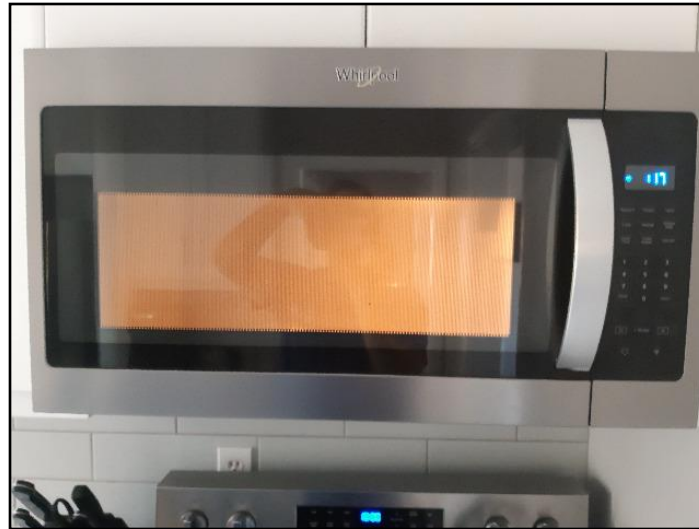
106. Microwave oven

• Microwave oven

normal operative on the day of inspection

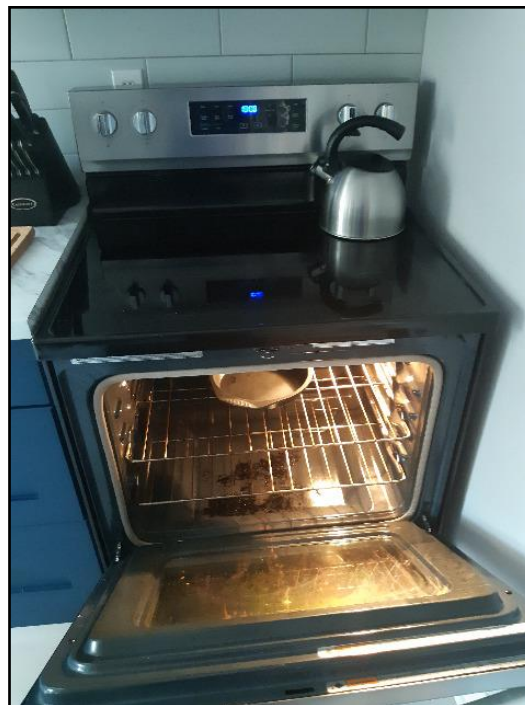
107. Range

- Range
normal operative on the day of inspection

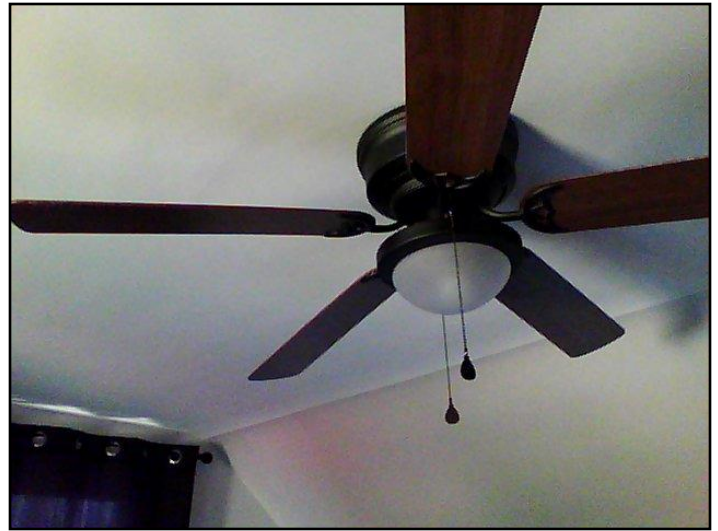
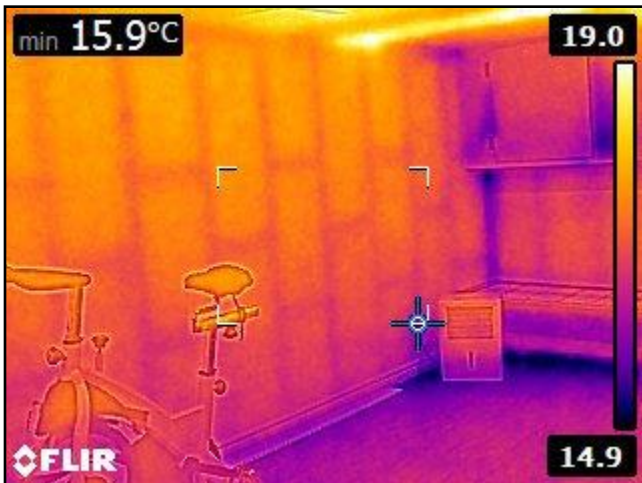
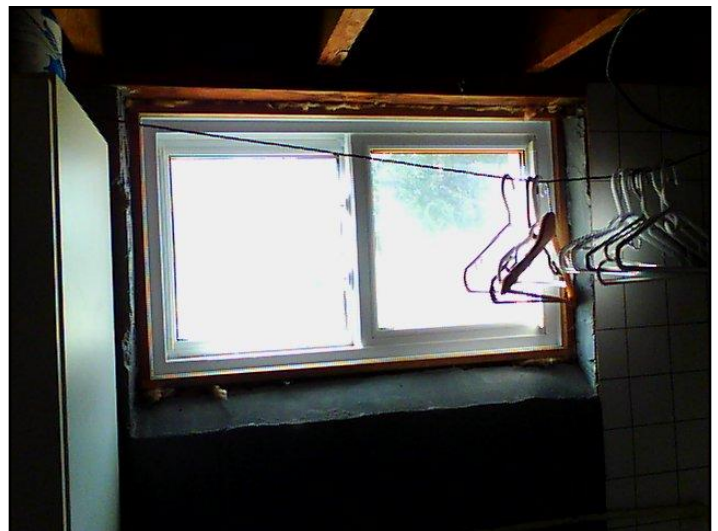
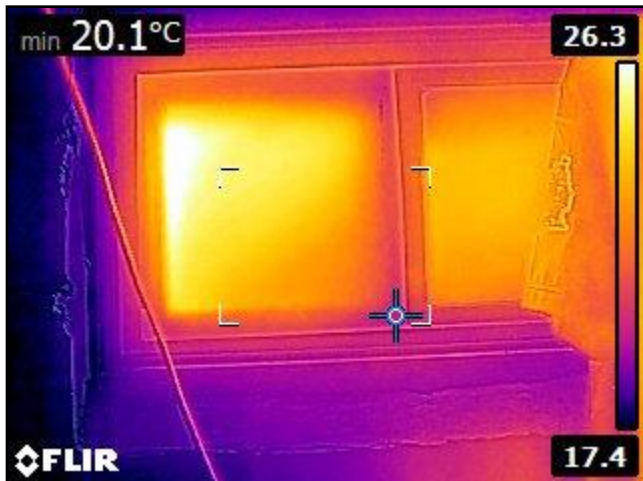
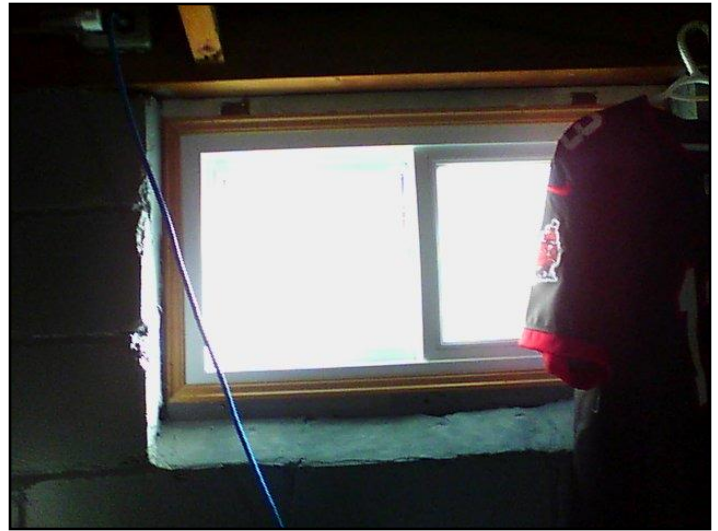
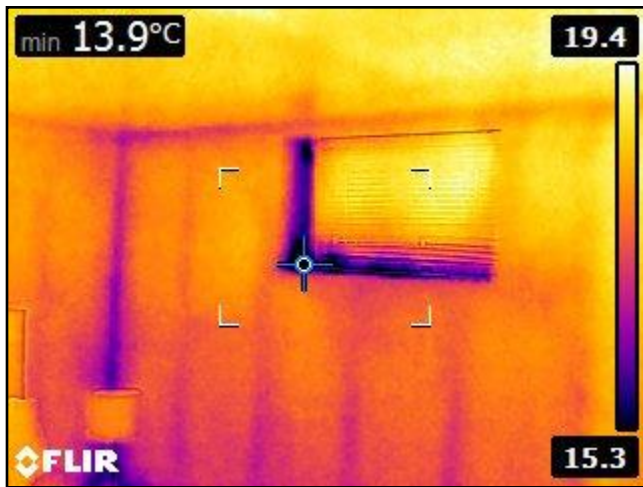
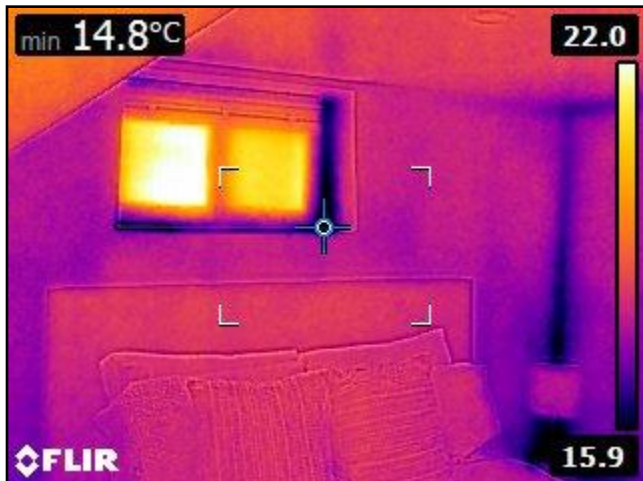
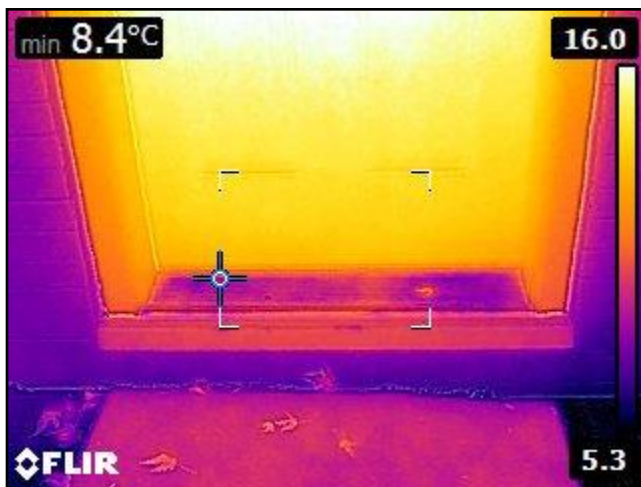
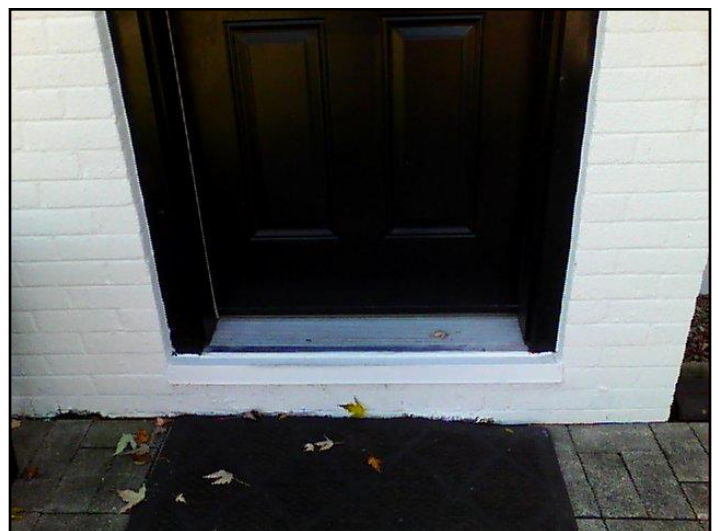
31. Condition: • Thermal inspection performed. Thermal images showing different areas in the house. Poor attic insulation above bedrooms, recommend adding insulation in these areas in the attic. Thermal bridging occurs in the walls, correction does not need at present. Basement walls were checked for moisture with a moisture meter and no moisture was detected on the day of the inspection.

Location: Various

Time: as soon as practical

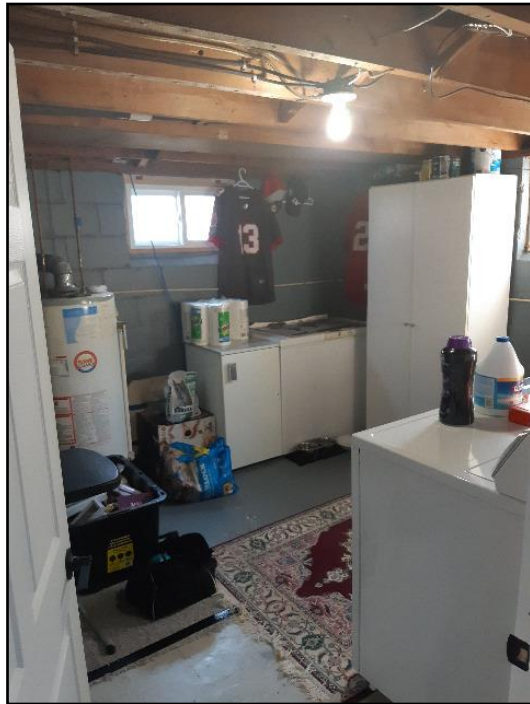
126. Poor fit

32. Condition: • [Poor fit](#)

Implication(s): Material deterioration

recommend filling cracks around the laundry area windows in the basement with foam to prevent draft air enter the building
